RE SMITHS FALLS 6 SOLAR PROJECT

Water Body Site Investigations Report

RE Smiths Falls 6 Solar Project

H334680-0000-07-124-0064

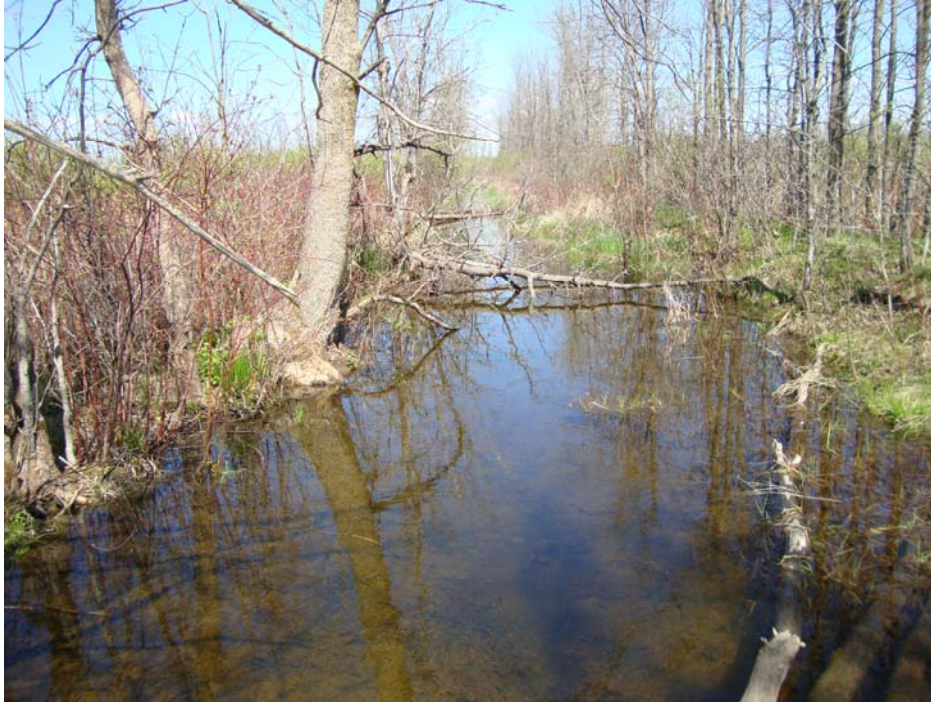
The waterbody corridor includes the watercourse channel itself and surrounding, naturally vegetated low lands/wetlands, adjacent to active agricultural fields. The watercourse is generally low gradient, consisting of slow-moving, run-type morphology. There is one small beaver dam across the channel, approximately half way across the Project site. The watercourse is approximately 4 to 5 m wide due to the impoundment created by the small dam, which extends to the western Project boundary. During the site investigation, water from the impoundment had inundated the existing water crossing that the farmer uses to access the northern portion of the property. The wetted channel downstream from the beaver dam was approximately 3 to 4 m wide.

Substrate in the channel is predominantly muck and other fine sediment. Water depth was approximately 0.60 m in the small beaver pond and 0.40 m downstream from the pond. The watercourse is relatively linear and was likely been channelized at some point in the past to facilitate agricultural activities.

**Figure 4.2 Unnamed Tributary Crossing Project Site –
View Upstream from Beaver Dam on the Project Site**

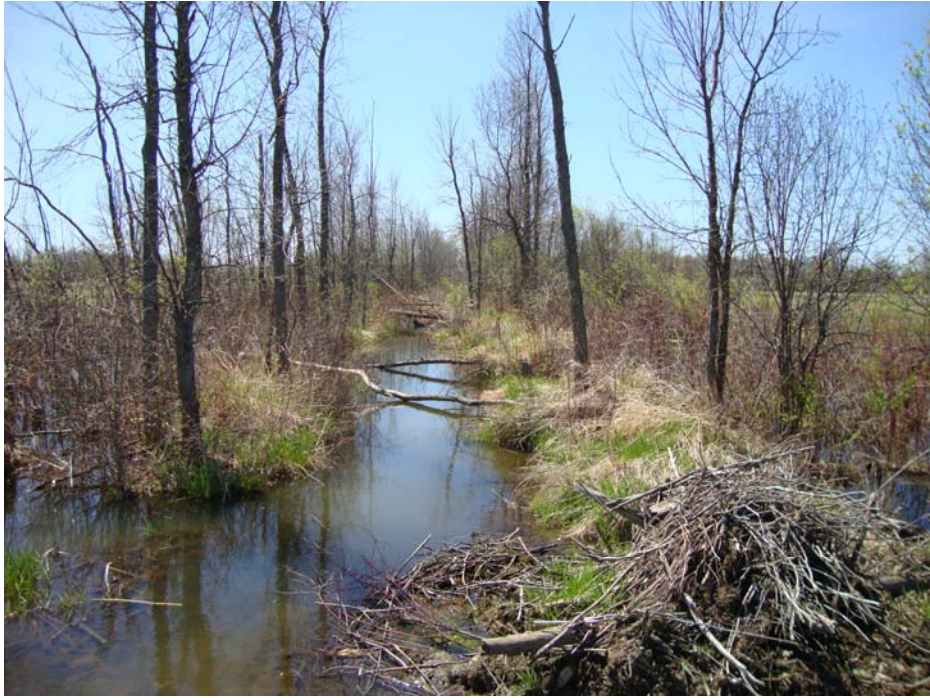
Figure 4.3 View Downstream from the Eastern Project Site Boundary

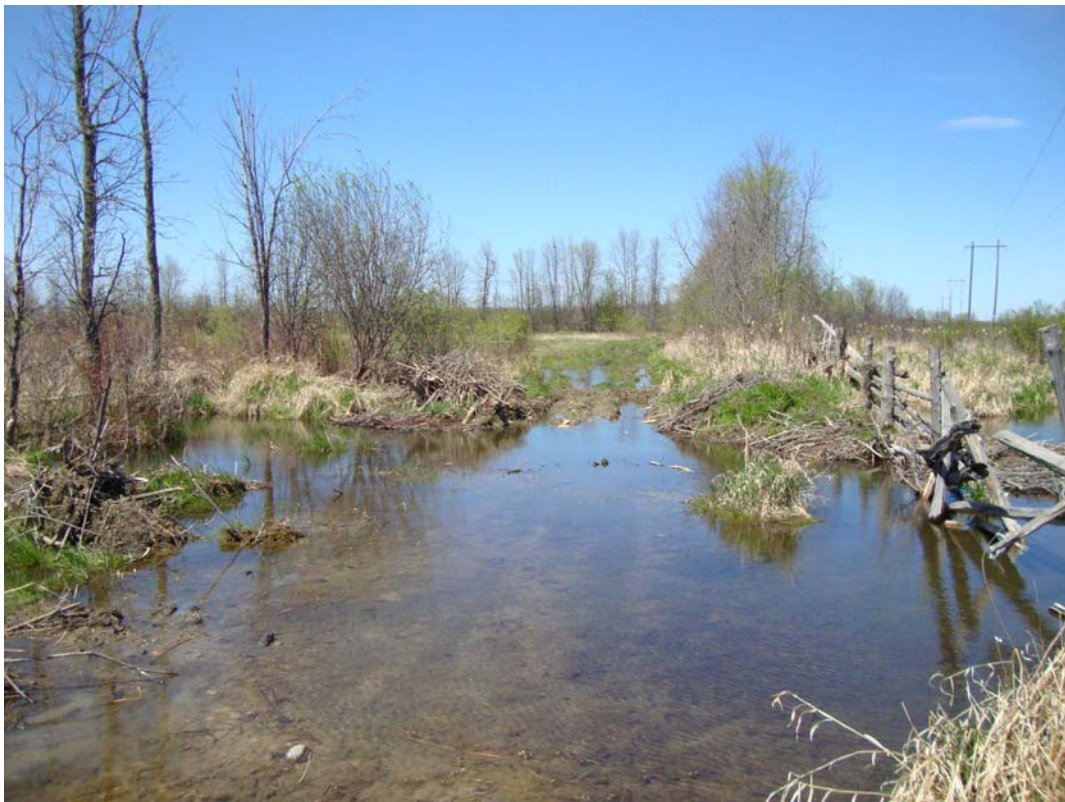
Several photos of the watercourse and riparian vegetation, as well as the inundated conditions at the existing water crossing, are shown in the following figures. Based on the results of the site investigation, it appears as though this stream is a permanent watercourse.

Figure 4.4 Inundation at the Existing Farmer's Water Crossing of the Unnamed Tributary at the Eastern Project Boundary Due to Beaver Dam

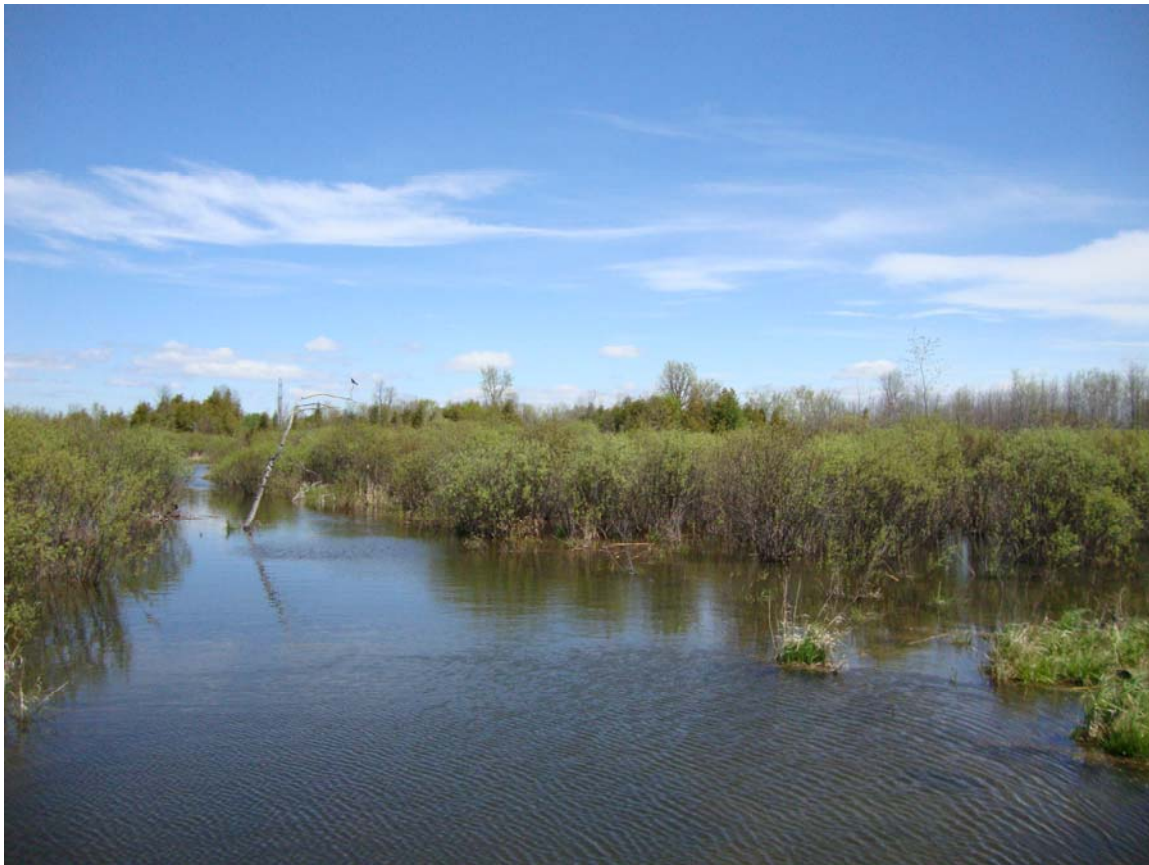
Immediately upstream from the Project site boundary, there is a beaver dam that creates a larger impoundment with flooded vegetation. A photograph of the beaver pond is shown in Figure 4.5.

Figure 4.5 Upstream View into Beaver Pond Adjacent to Eastern Project Site Boundary

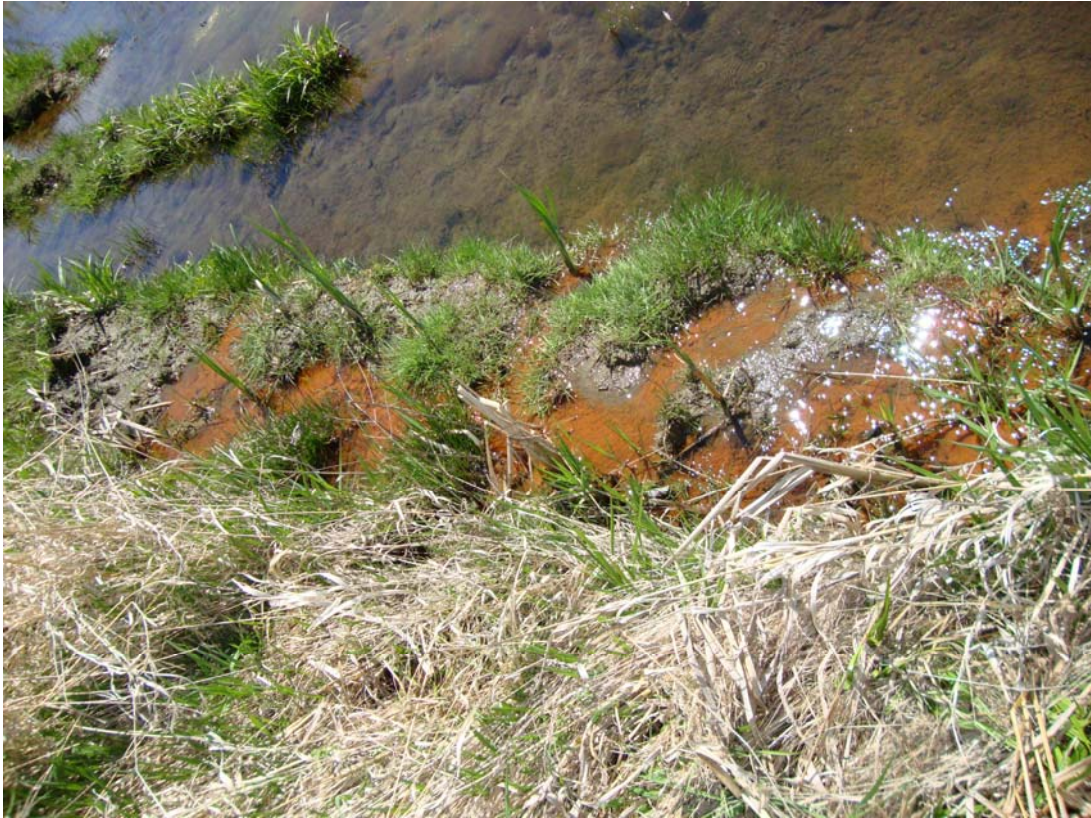
A potential groundwater seepage area was observed on the edge of the riparian corridor in an area of rutting from agricultural activities. At the edge of pooled water in the one of the ruts, there was an accumulation of orange-colored flocculent, which is typical of oxidation of iron when groundwater is aerated when it emerges at the land surface. The area is shown in Figure 4.1 and a photograph is provided in Figure 4.6. No other such areas were observed on or within 120 m adjacent to the Project site.

Figure 4.6 Photograph of Groundwater Seepage Area near Eastern Project Boundary

The REA Regulation prohibits development of solar panels, inverters and transformers within 30 m of the seepage area, as shown in the setback identified in Figure 4.1. The Project footprint boundary (e.g., the limit of development) will extend up to the 30-m setback, therefore, an EIS will be required to assess the potential effects of the Project on the seepage area and identify mitigation requirements.

Based on the results of the Site Investigation, the only correction to the Water Body Records Review Report (Hatch Ltd., 2010) would be to add the groundwater seepage area discussed in Section 4.2, since this was not noted in any of the records that were reviewed.
