RE SMITHS FALLS 2 SOLAR PROJECT

Water Body Records Review Report

H334680-0000-07-124-0031 Rev. 1 April 15, 2011

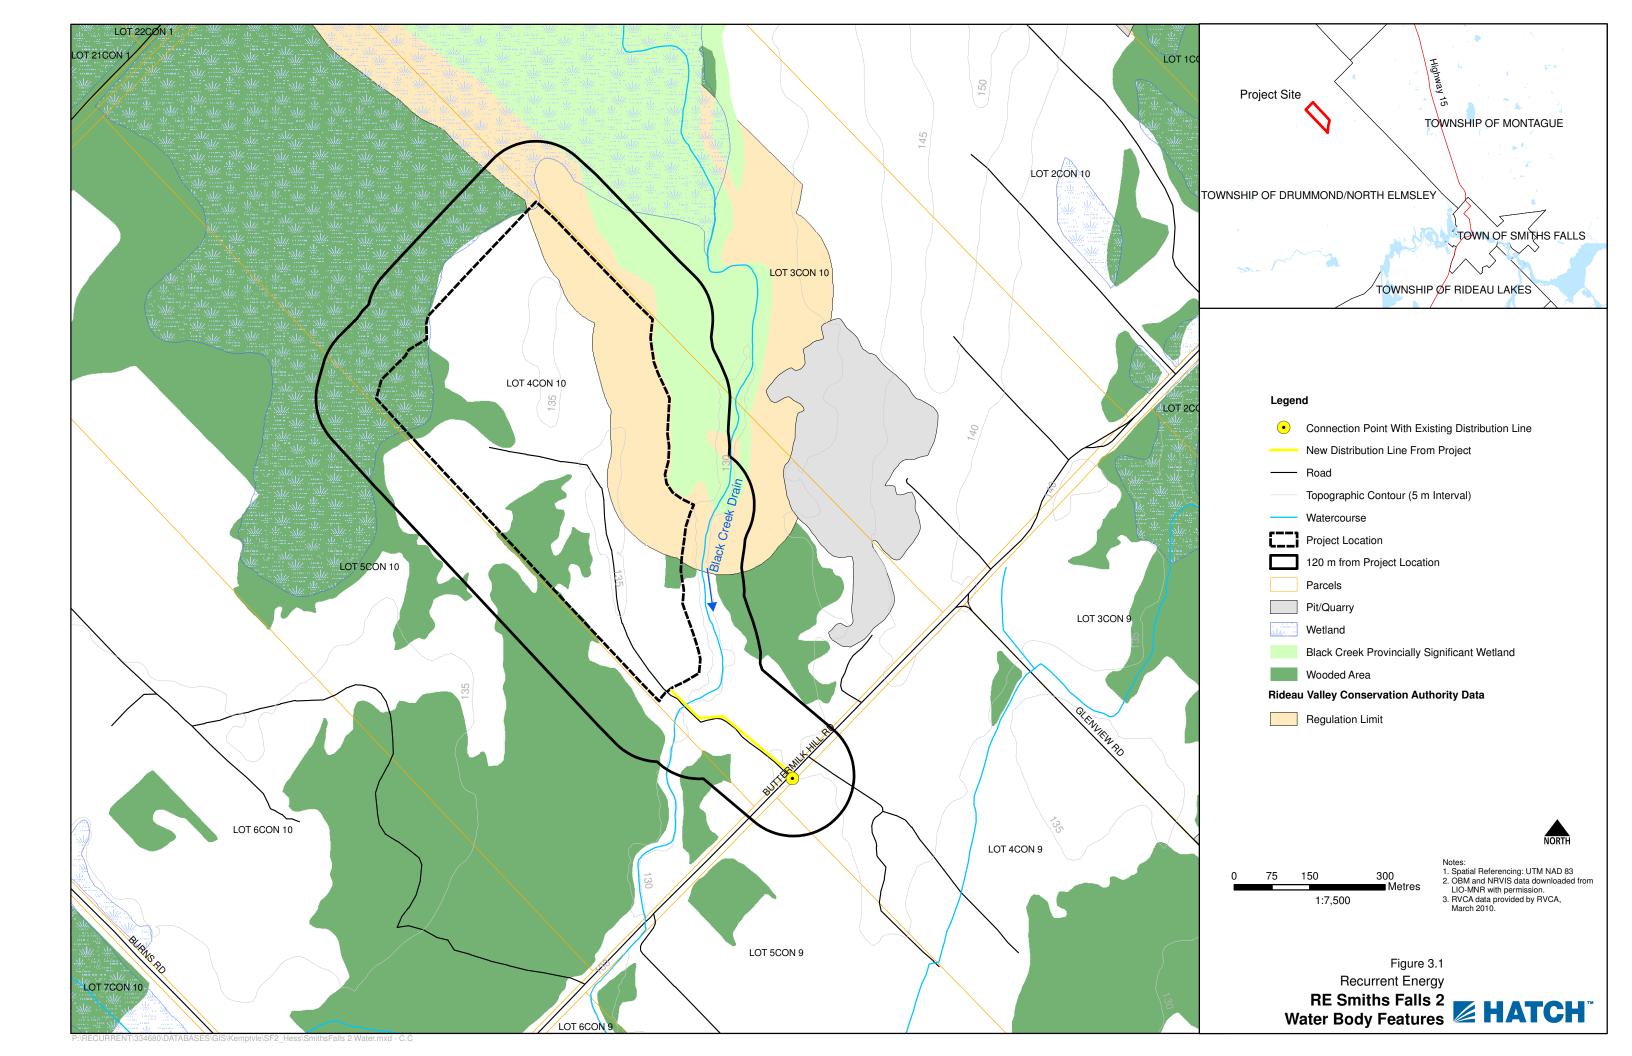
Table 3.1 summarizes the results of the Record Review according to the features identified in Section 1.2. A map depicting the identified water features on and in proximity to the Project location is provided in Figure 3.1.

Mapping data obtained from LIO indicates there are no watercourses or waterbodies within the proposed solar panel development area. However, Black Creek Drain runs along the southeastern boundary of the Project location. The existing access road, which may require upgrading, crosses the Black Creek Drain immediately south of the Project location. The proposed new section of distribution line from the Project will also cross Black Creek Drain at the site of the existing access road water crossing.

Black Creek Provincially Significant Wetland (PSW) is present adjacent to the eastern section of the Project location.

Therefore, depending on the layout of the proposed solar facility, some components of the project could potentially be located within 120 m of the average annual high water mark of Black Creek Drain, a warmwater, permanent watercourse. This drain will also be crossed by a permanent access road and a new distribution line from the Project.
