## Water Body Site Investigation Report

Norfolk Bloomsburg TS  
Solar Energy Project

H335467

**Axio Power Canada Inc./SunEdison Canada  
Norfolk Bloomsburg TS - Solar Energy Project**

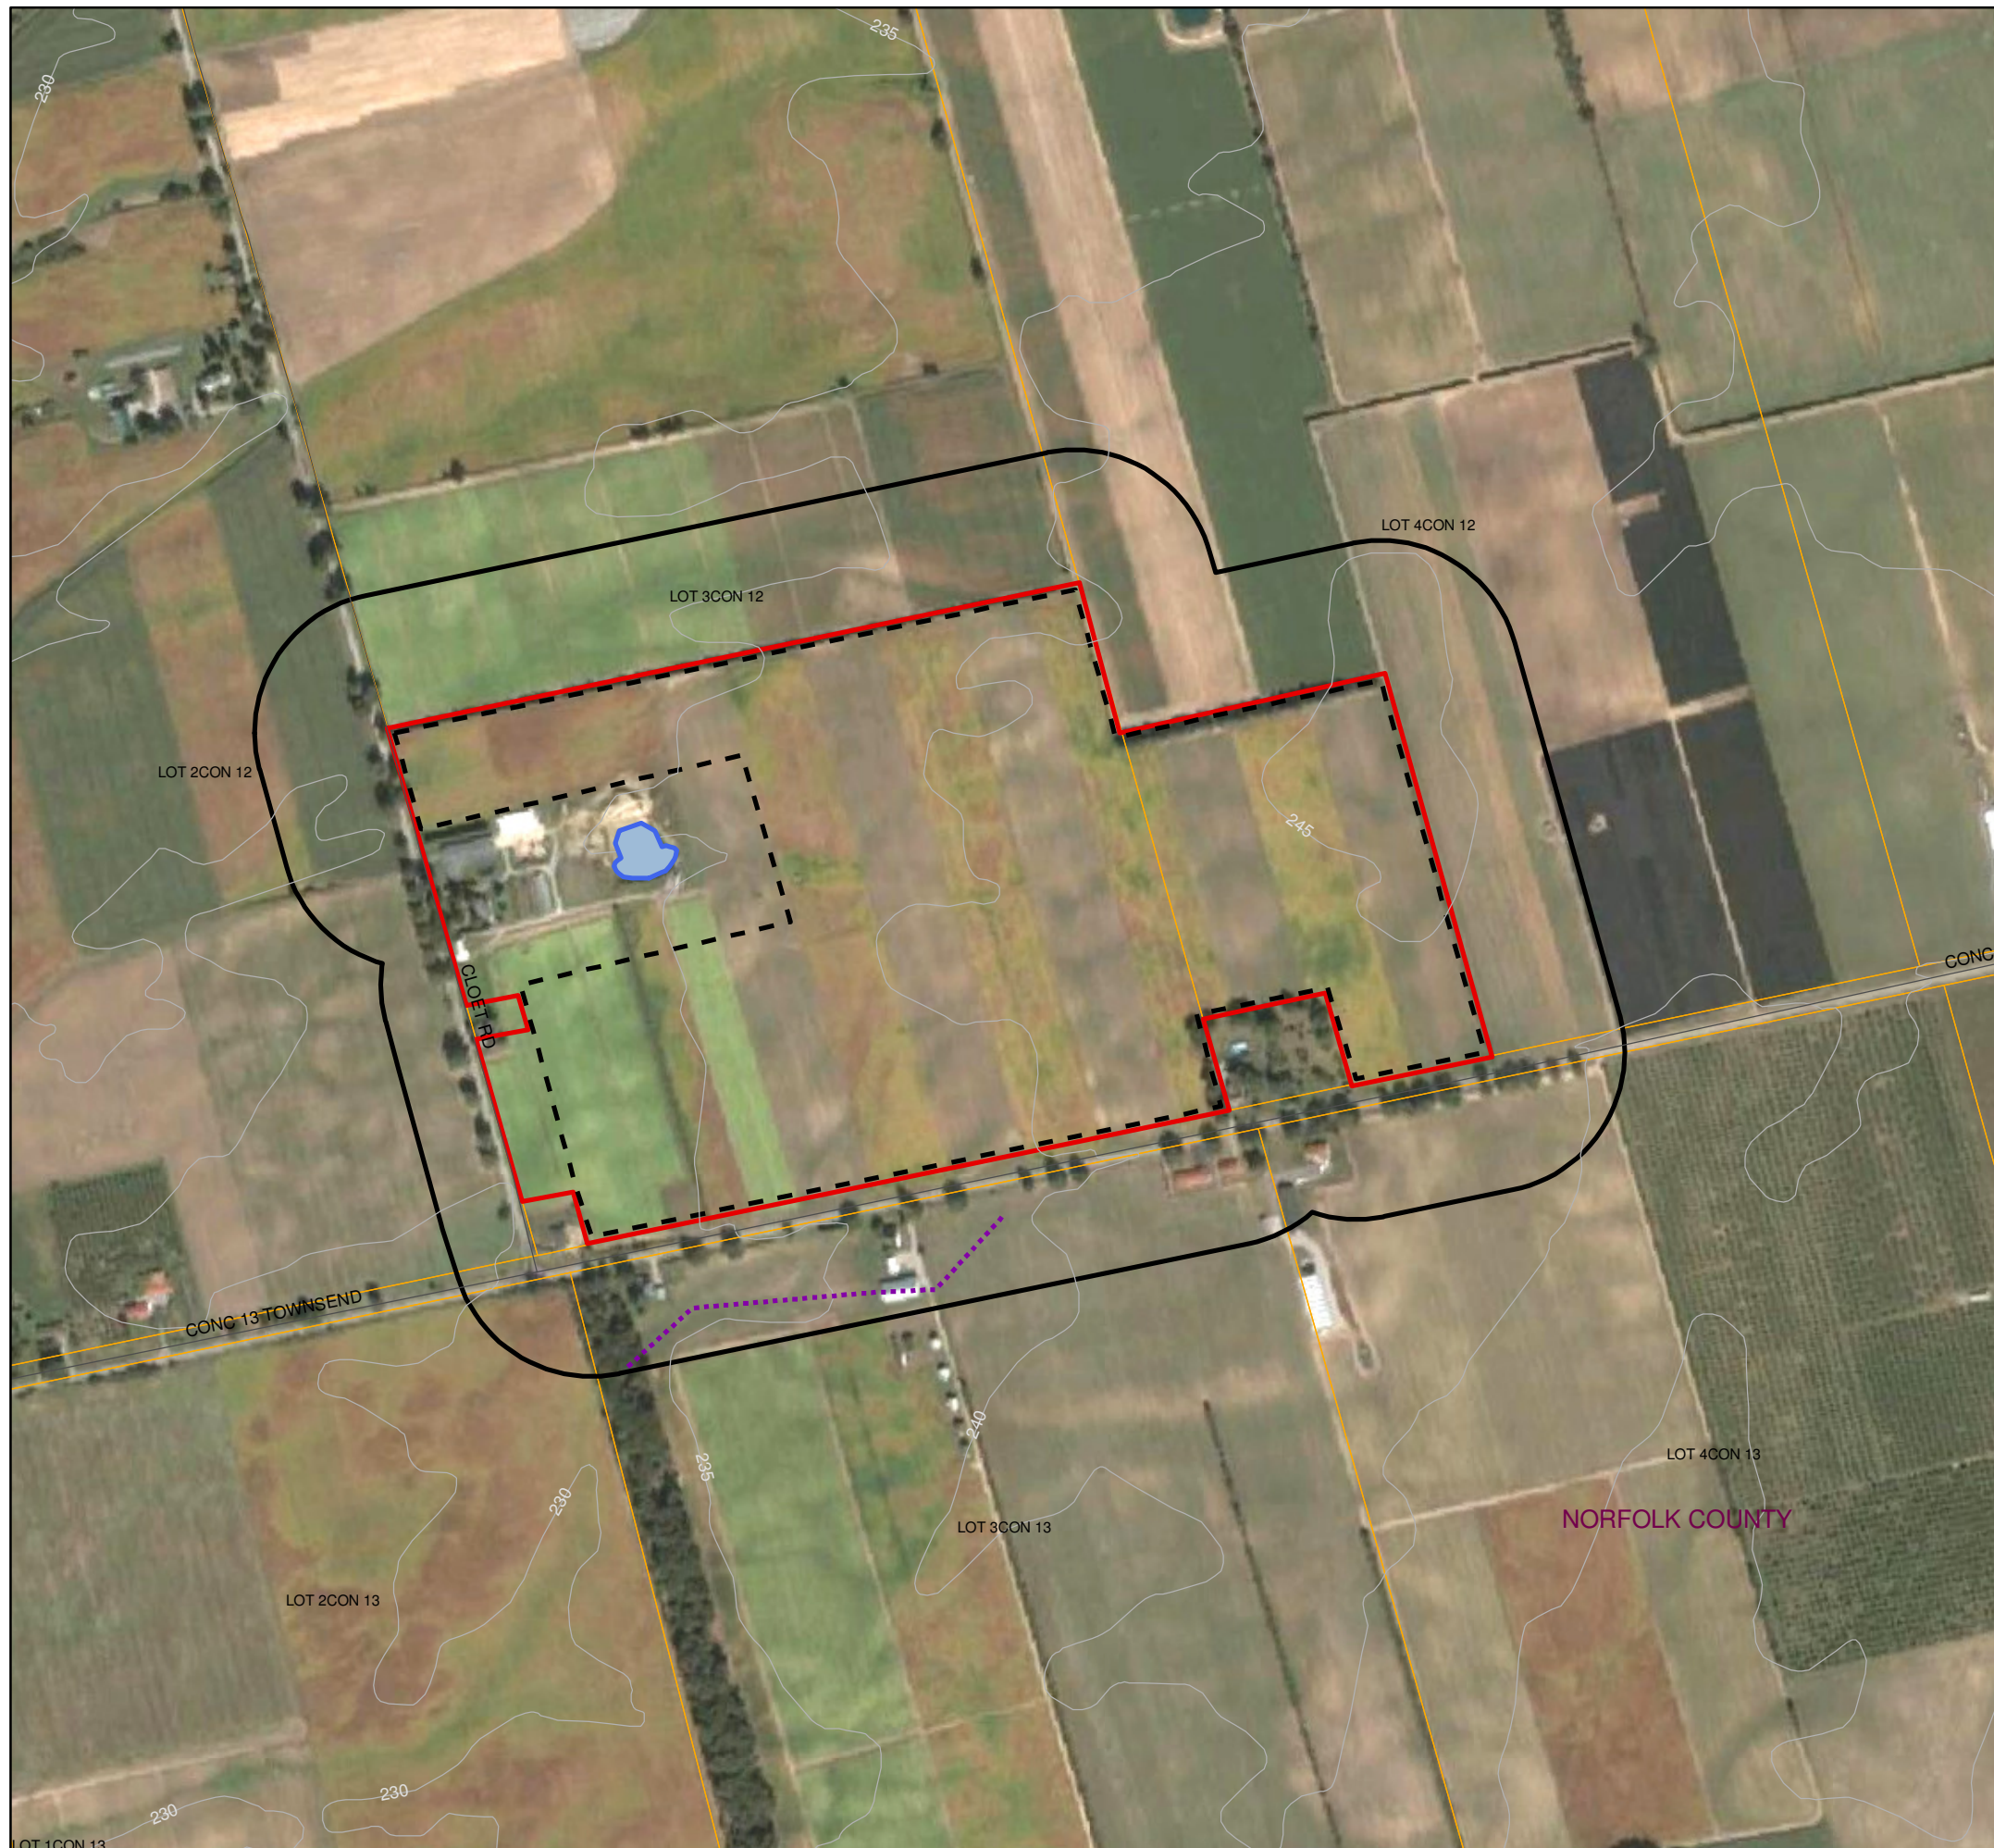
Figure 4.1  
Axio Power Canada Inc./SunEdison Canada  
**Norfolk Bloomsburg TS**  
**Water Body Features**

This section documents the results of the site investigation and discusses specific water features observed on and within 120 m of the Project Location. Water features confirmed to be on or within 120 m of the Project Location are shown in Figure 4.1.

The water features identified on and within 120 m of the Project Location are discussed in the following sections. These include the intermittent tributary of Davis Creek identified on NRCAN topographic mapping, and a dug pond located within 120 m of the Project Location. No lakes or grassed waterways, drainage ditches, channels or seepage areas were identified on or within 120 m of the Project Location.

As shown on Figure 4.1 and summarized in Table 5.1., there are no water bodies on or within 120 m of the Project Location. As a result, a Water Body Environmental Impact Study is not required.

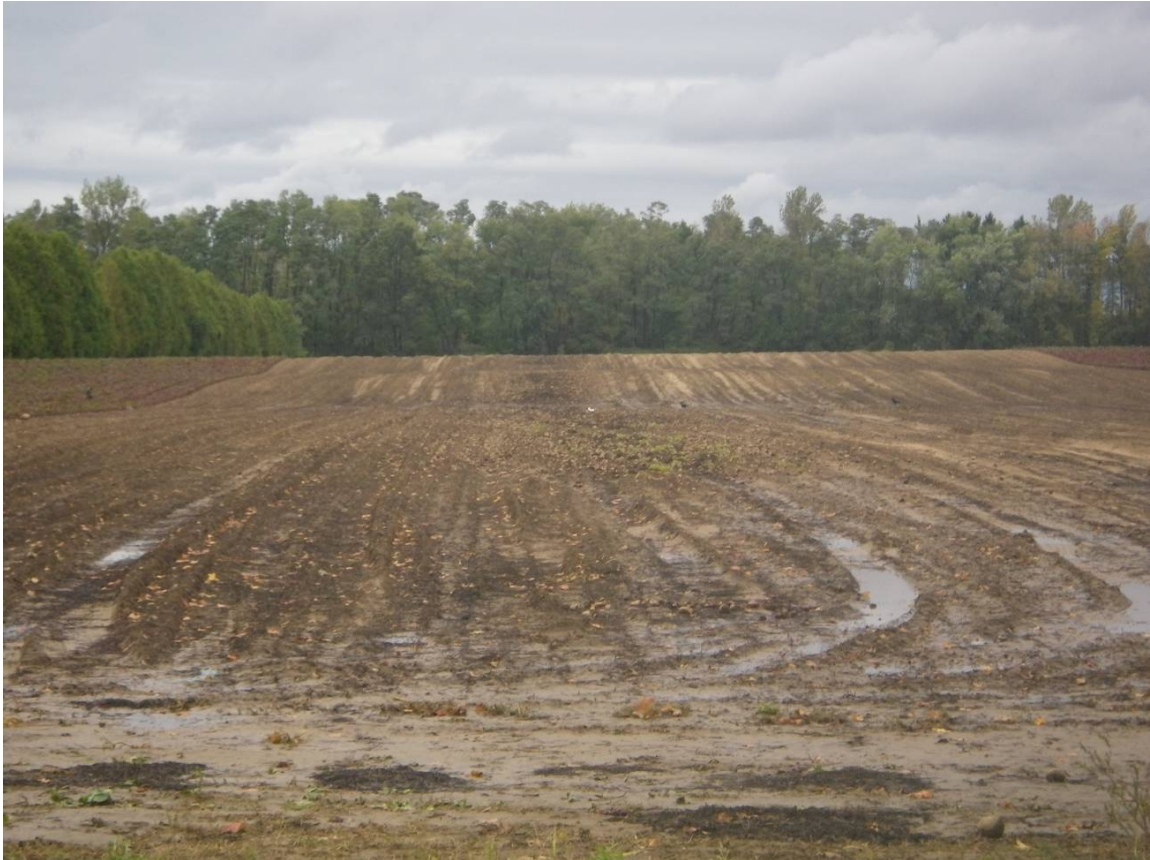
A site investigation, completed on October 2, 2010, determined that the drainage feature identified on the NRCAN topographic mapping does not exist on or within 120 m of the Project Location. Antecedent moisture conditions during the site investigation were fairly high as it had rained the previous day and the fields were wet but no evidence of a permanent or intermittent stream was found. The rolling topography where this drainage feature is shown on the NRCAN mapping is actively used for the production of row crops. Although this area has a natural slope in the topography that would naturally convey water during heavy precipitation events, there was no defined channel or established vegetation that would characterize this as a permanent or intermittent stream. Temporary channels for surface drainage, such as furrows or shallow channels that can be tilled and driven through and temporarily ponded areas that are normally farmed do not meet the definition of a water body according to subsection 1 (1) of the REA Regulation. A photograph showing the location where this drainage feature is depicted on the NRCAN topographic mapping is provided in Figure 4.2.

**Figure 4.2** Photograph of the agricultural field where the tributary of Davis Creek is shown on the NRCAN mapping

Based on the results of the site investigation, the drainage feature identified on the NRCAN mapping does not exist and therefore does not meet the definition of a water body as defined in subsection 1 (1) of the REA Regulation. There were no water features observed on or within 120 m of the Project Location.

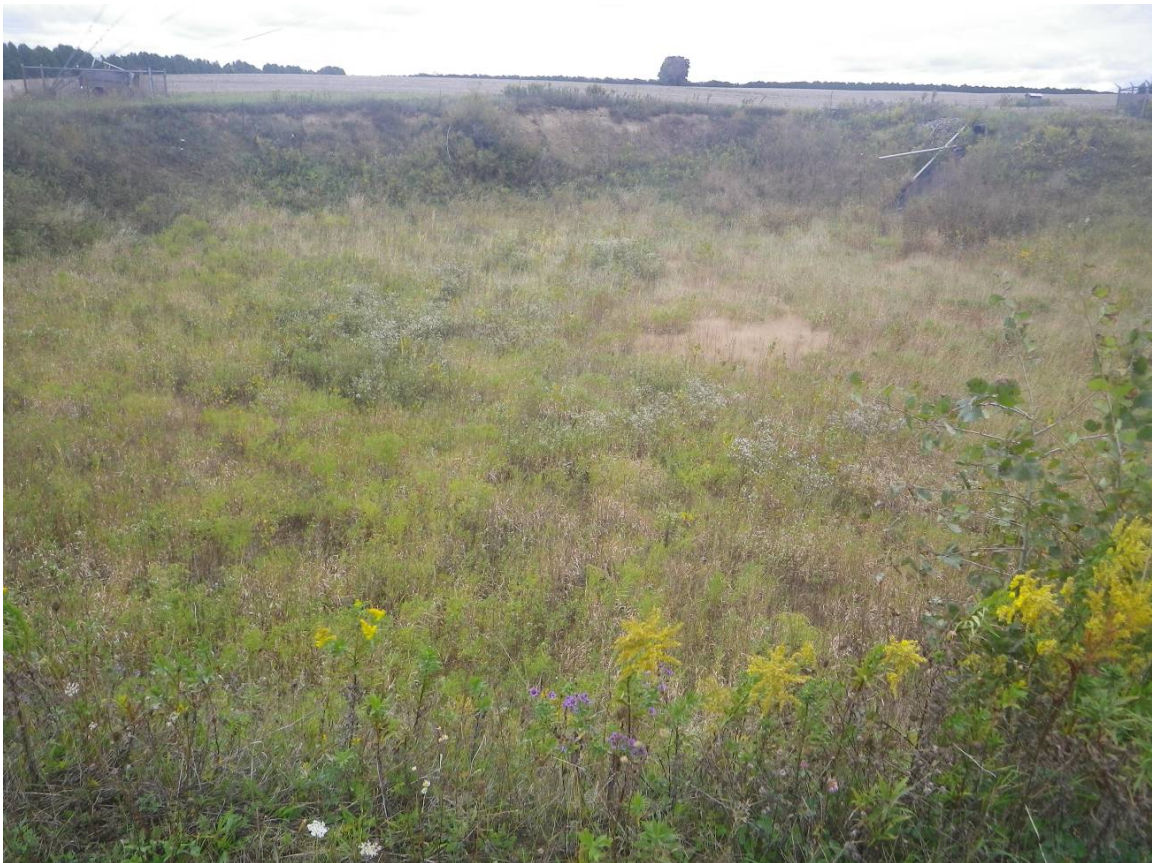
As mentioned in Section 4.3, the site investigation confirmed the presence of a pond approximately 70 m west of the Project Location, within the 120 m setback. This pond was identified in the Water Body Records Review Report (Hatch Ltd., 2011), however, the site investigation determined that it is not a lake, but rather a dugout pond and does not meet the definition of a water body.

The dugout pond is approximately 50 m long, 25 m wide and 10 m deep. There was no water or aquatic vegetation observed within the dugout pond during the time of the site investigation. A photograph of the dugout pond is provided in Figure 4.3.

**Figure 4.3 Photograph of Dry Dugout Pond near the Northwest Portion of Project Location**

Based on the results of the site investigation, the water feature identified during the site investigation is described as a dugout pond. Dugout ponds are not considered a water body as defined in subsection 1 (1) of the REA Regulation. No other water features were observed on or within 120 m of the Project Location. Therefore, there are no specific setback requirements for development in proximity to this feature.
