# WATER REPORTS

## Marsh Hill Solar Farm

# WATER ASSESSMENT REPORT

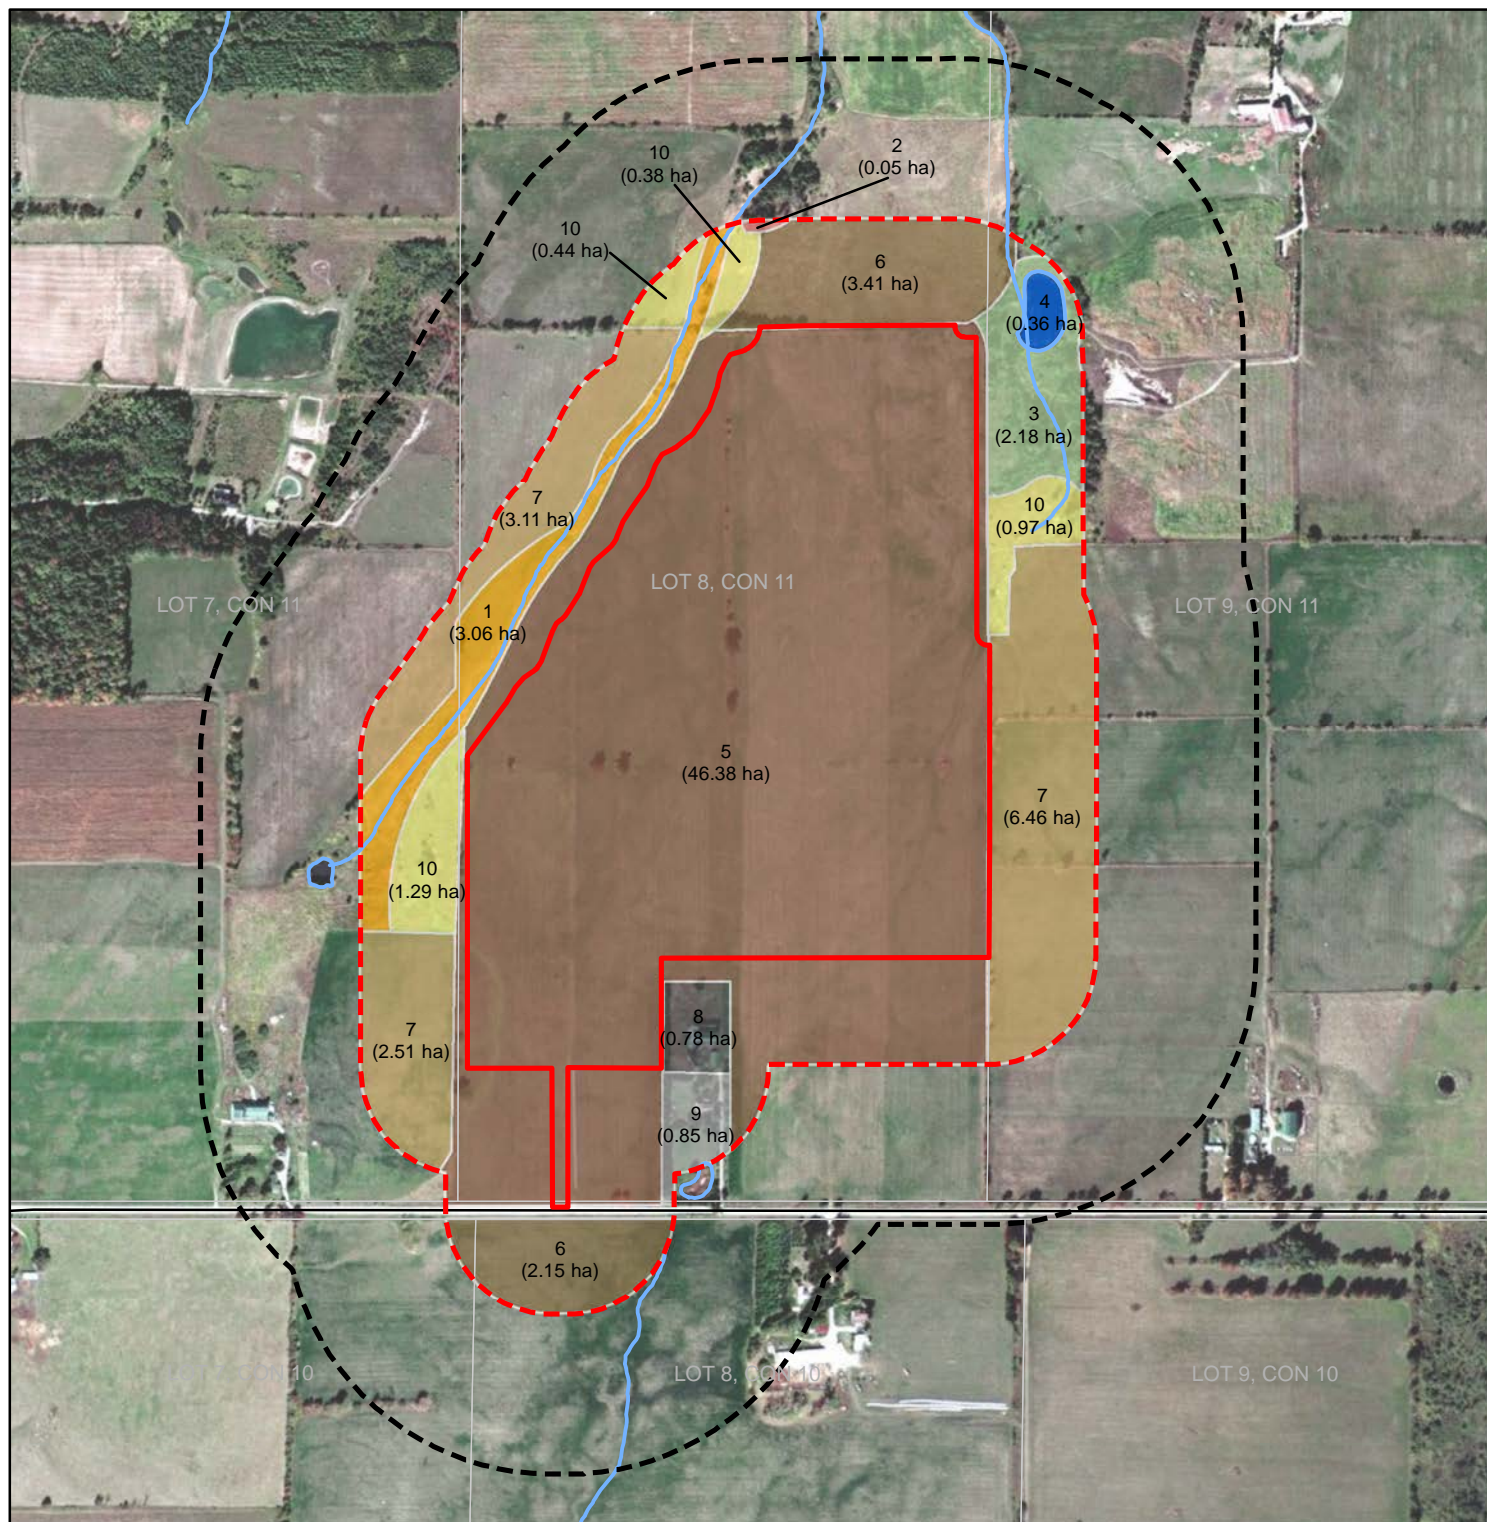
**Figure 5:  
Ecological Land Classification**

This 0.36 ha open water area is located within the northeast 120 metre setback of the project location. The surrounding vegetation community consists of WOMM4-1: Fresh – Moist White Cedar – Hardwood Mixed Woodland Type (**Figure 5**) which prevented visual observation during site investigations. As discussed above in **Section 7.3** and shown on **Figure 4**, access to this area was restricted therefore a detailed assessment could not be completed. This feature has been identified as Candidate Amphibian Breeding Habitat.

- 1) MAMM1-3: Reed Canary Grass Graminoid Mineral Meadow Marsh Type
- 2) SWM: Mixed Swamp
- 3) WOMM4-1: Fresh - Moist White Cedar - Hardwood Mixed Woodland Type
- 4) Open Aquatic
- 5) Ploughed Field
- 6) OAGM1: Annual Row Crops
- 7) OAGM2: Perennial Cover Crops
- 8) IAGM1: Agricultural Buildings
- 9) CVR\_4: Rural Property
- 10) MEFM4: Fresh-Moist Forb Meadow Ecosite

Stream 2 is encompassed by the surrounding vegetation community MAMM1-3: Reed Canary Grass Graminoid Mineral Meadow Marsh (**Figure 5** and **Photo 4, Appendix D**). Within the northern setback, this stream has a defined channel with an average width of 0.44 metres and an average depth of 0.06 metres. Substrate was characterized by scattered boulders, cobble, sand, detritus and muck (**Photo 5, Appendix D**). Overhanging macrophytes, boulders, cobble, woody debris and organic debris comprise in-stream cover (10%, 5%, 10%, 5% and 5% respectively). No in-stream vegetation was observed. Within the western setback, Stream 2 displays uniform habitat characterized by a narrow channel with thick overhanging vegetation within marsh habitat (See **Photo 6** and **7, Appendix D**). Average width of this narrow channel was 0.20 metres with a depth of 0.04 metres. Substrate was characterized by muck and detritus with in-stream cover dominated by overhanging and in-stream vascular macrophytes (50% - 100%) with minimal organic debris (0 – 15%). No evidence of groundwater seepage was observed.

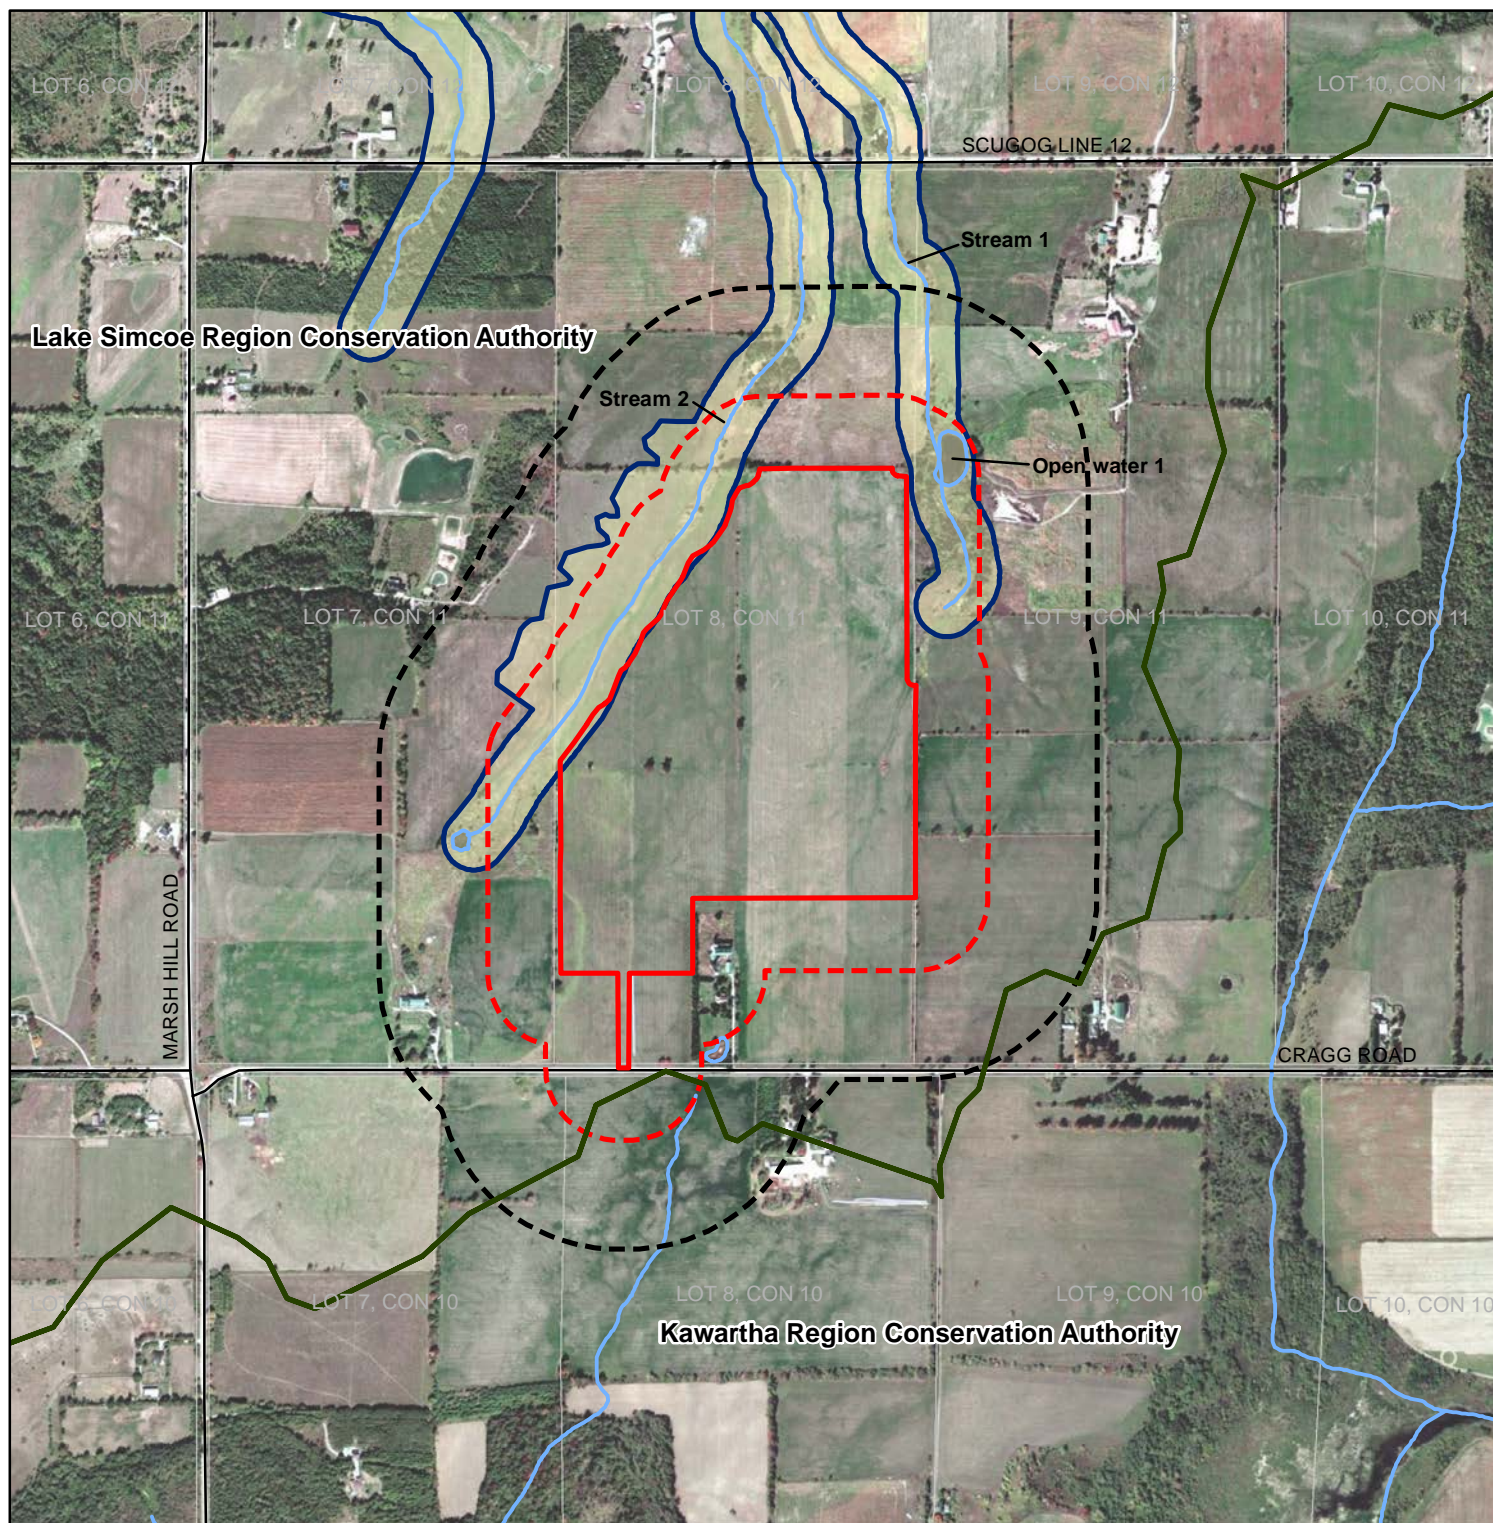
**Figure 6:  
Water Assessment  
Site Investigation**

Based on the results of the site investigations, no previously unidentified water bodies were identified within 120 metres of the project location. The extent of Stream 1 mapped within the eastern project location does meet the definition of a water body under *Ontario Regulation 359/09* (i.e., is not a permanent or intermittent stream) therefore mapping has been refined for this feature and the regulation area associated with it has been removed from LSRCA Regulation Mapping (**Figure 6**).

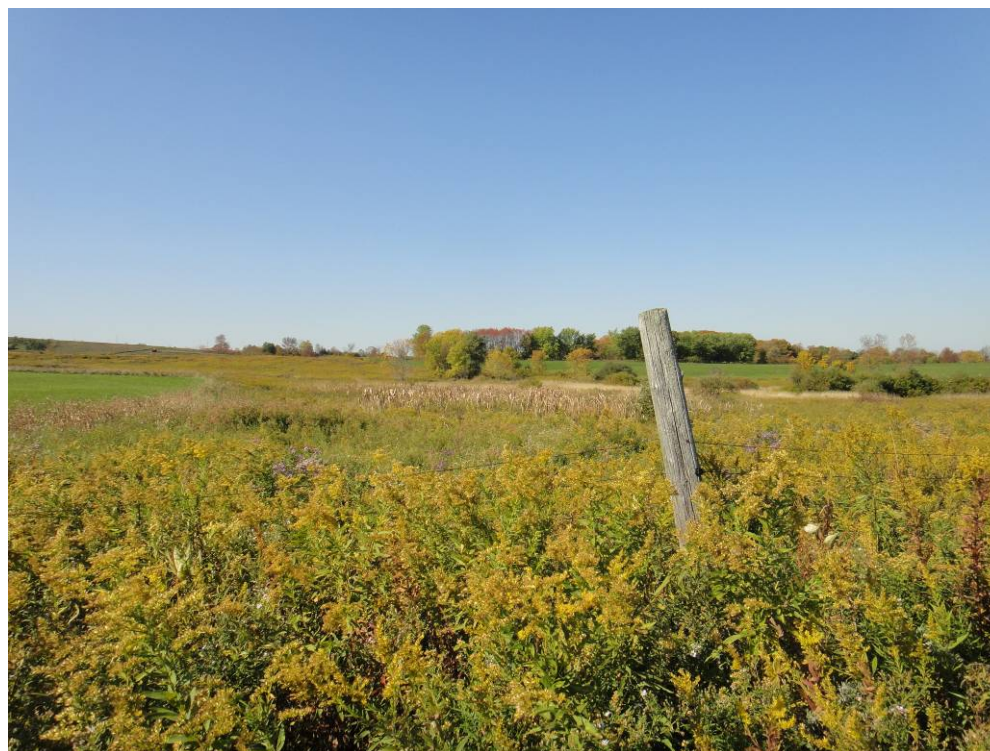
Cattail Marsh  
associated  
with MAMM1-  
3: Reed  
Canary Grass  
Graminoid  
Mineral  
Meadow  
Marsh in the  
western 300  
m setback.

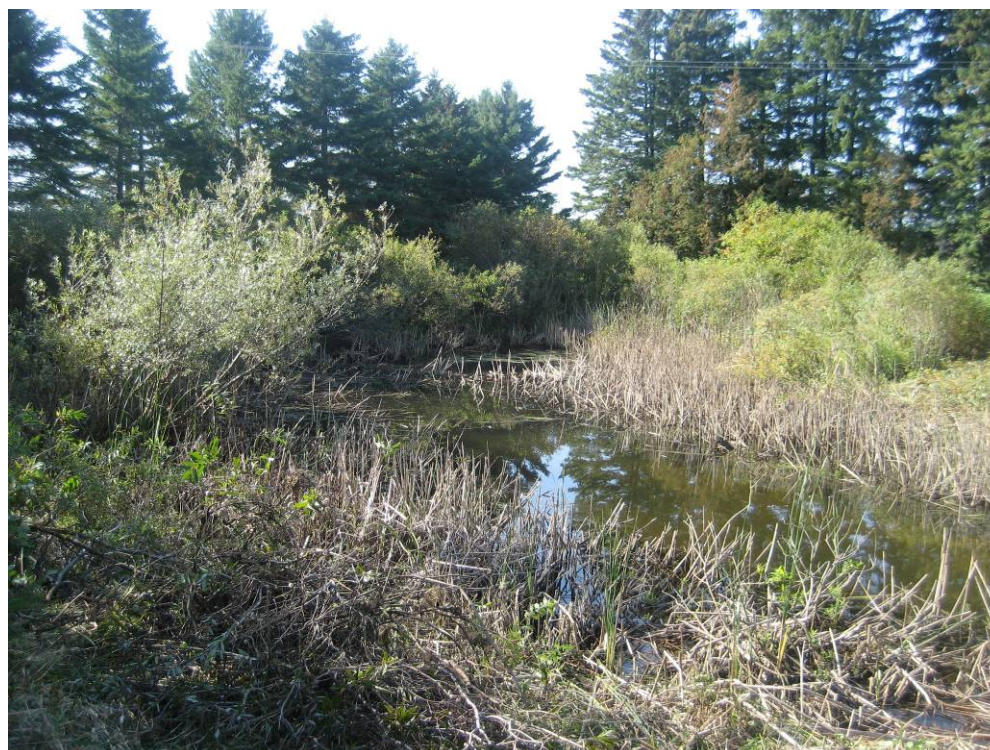
**Photo 2**

Open aquatic  
within  
southern 300  
m setback  
area  
associated  
with CVR\_4:  
Rural  
Property.

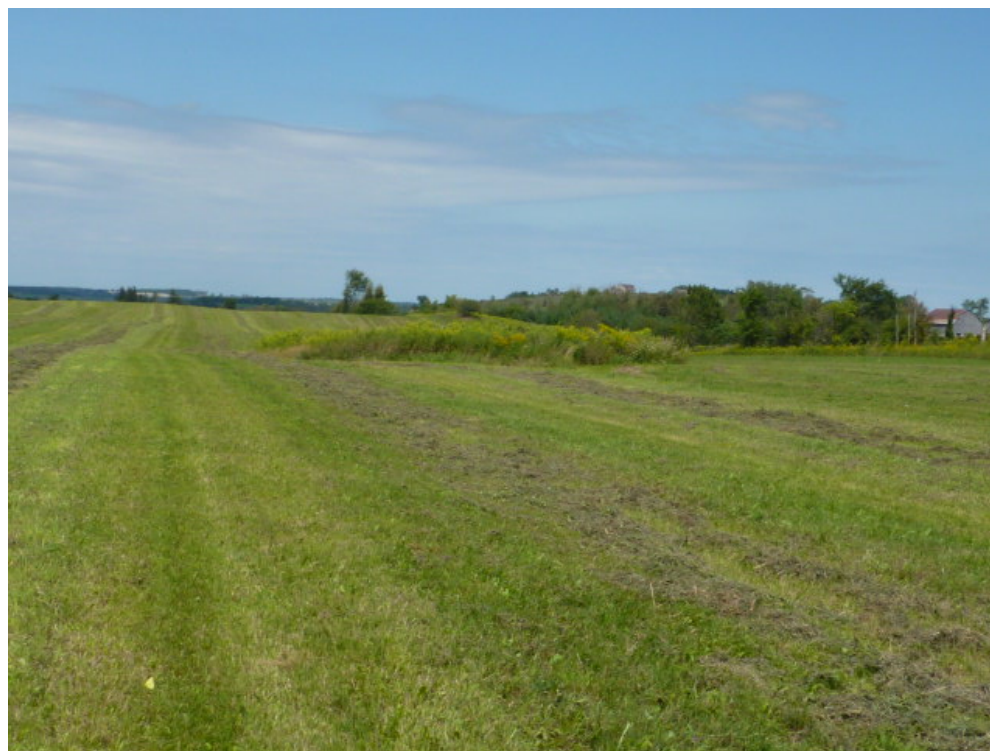
**Photo 3**

No evidence  
of Stream 1  
channel or  
swale where  
mapping  
indicated  
within the  
eastern  
project  
location.

Facing north.

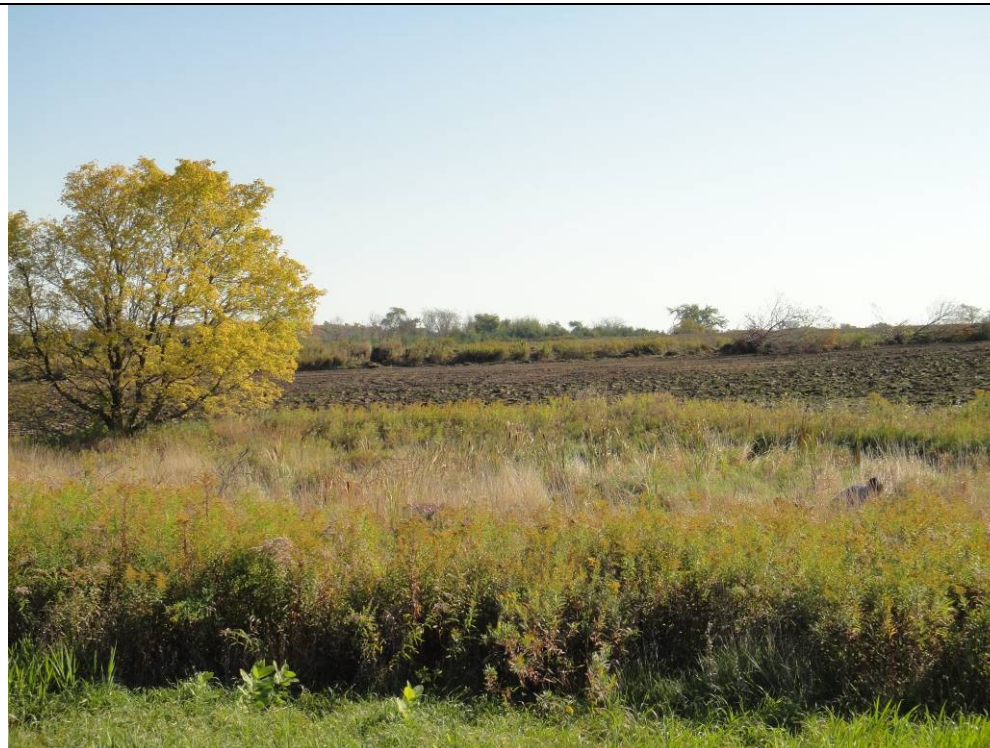
**Photo 4**

Reed Canary  
Grass  
Graminoid  
Mineral  
Meadow  
Marsh habitat  
encompassing  
Stream 2.

Facing east.

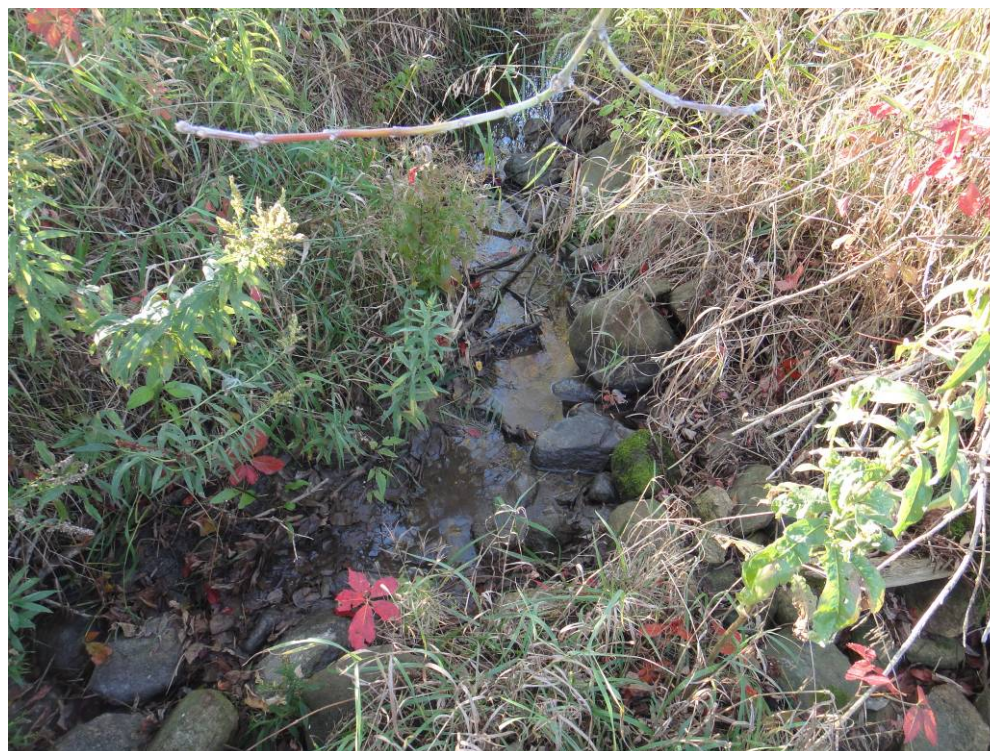
**Photo 5**

Stream 2 near  
northern  
extent of land  
parcel.

Facing  
downstream.

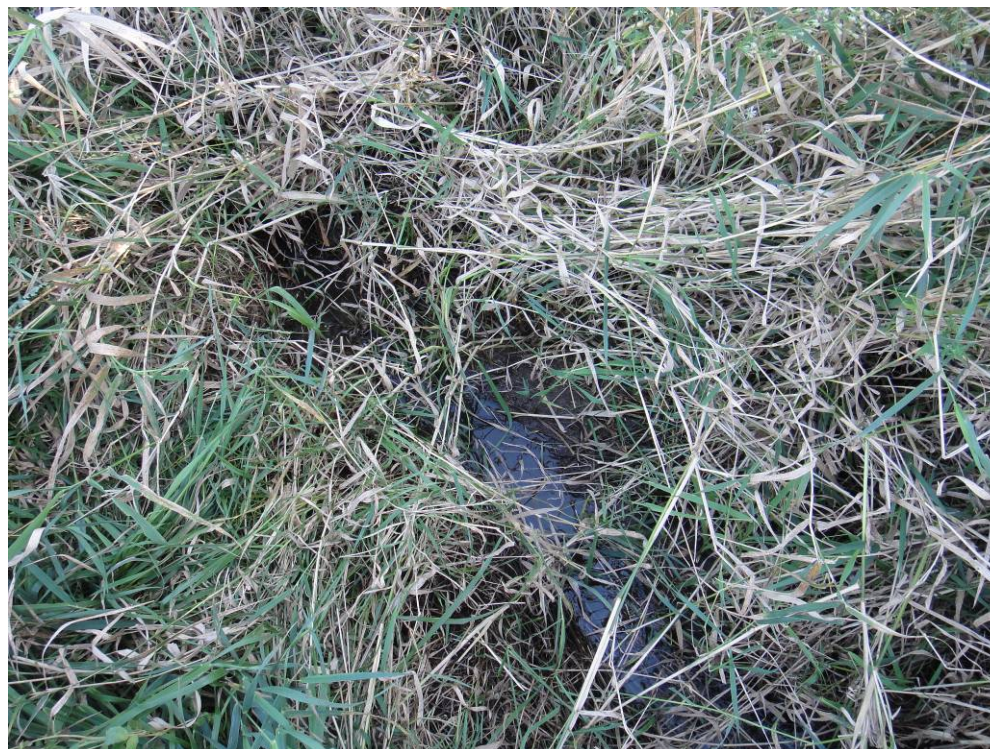
**Photo 6**

Small, heavily  
vegetated  
channel within  
Reed Canary  
Grass  
Graminoid  
Mineral  
Meadow  
Marsh  
characteristic  
of Stream 2.

Facing  
upstream.

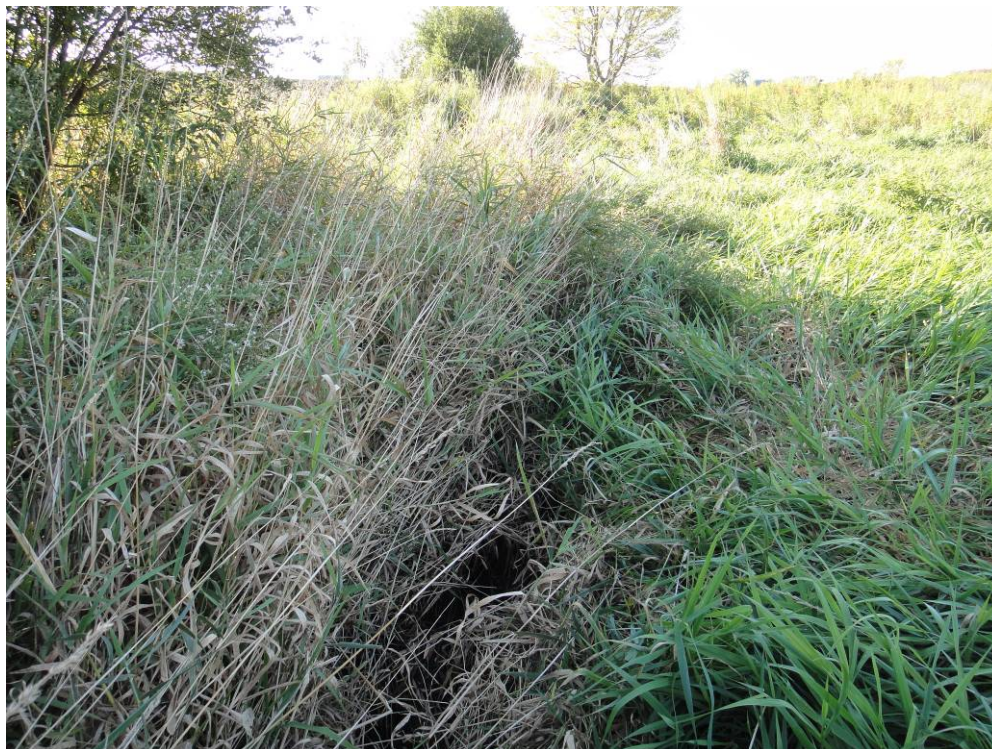
**Photo 7**

Abundant  
vegetation  
consistent  
along Stream  
2 within the  
project  
location  
setback.

Facing  
upstream.

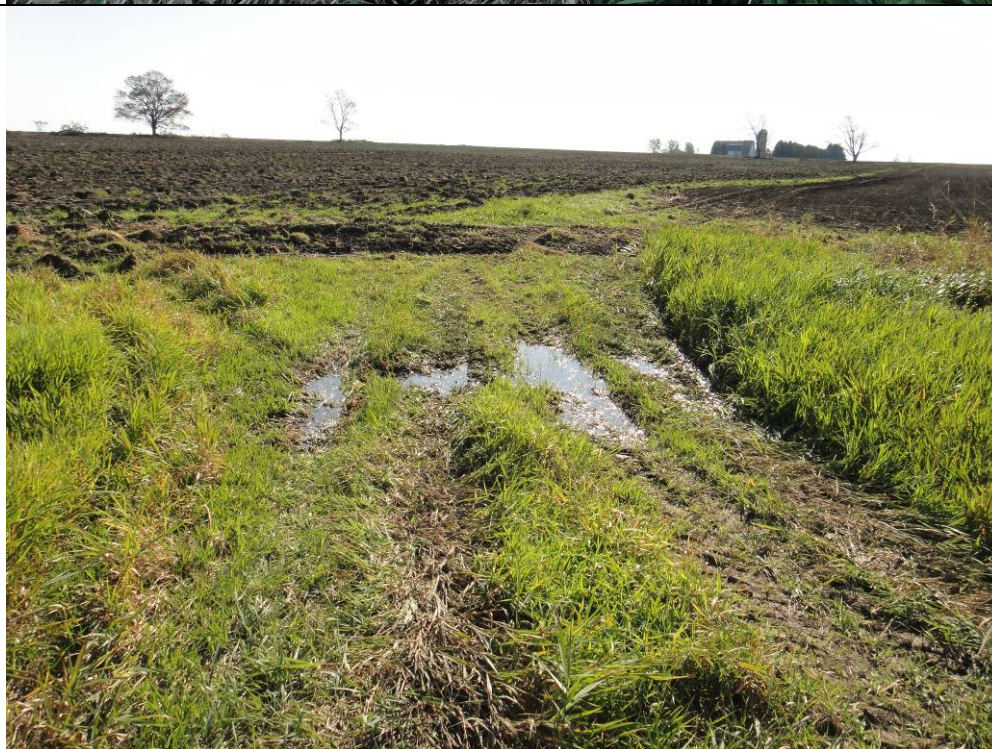
**Photo 8**

Two crossings were observed along Stream 2 for agricultural use. At the time of site investigations in October 2011, depressed tire tracks have formed pools of water with minimal flow (**Photo 8, Appendix D**). Another crossing with depressed tire tracks and minimal flow along Stream 2 was observed further

Crossing along  
Stream 2  
during high  
flow  
conditions.

Facing west.

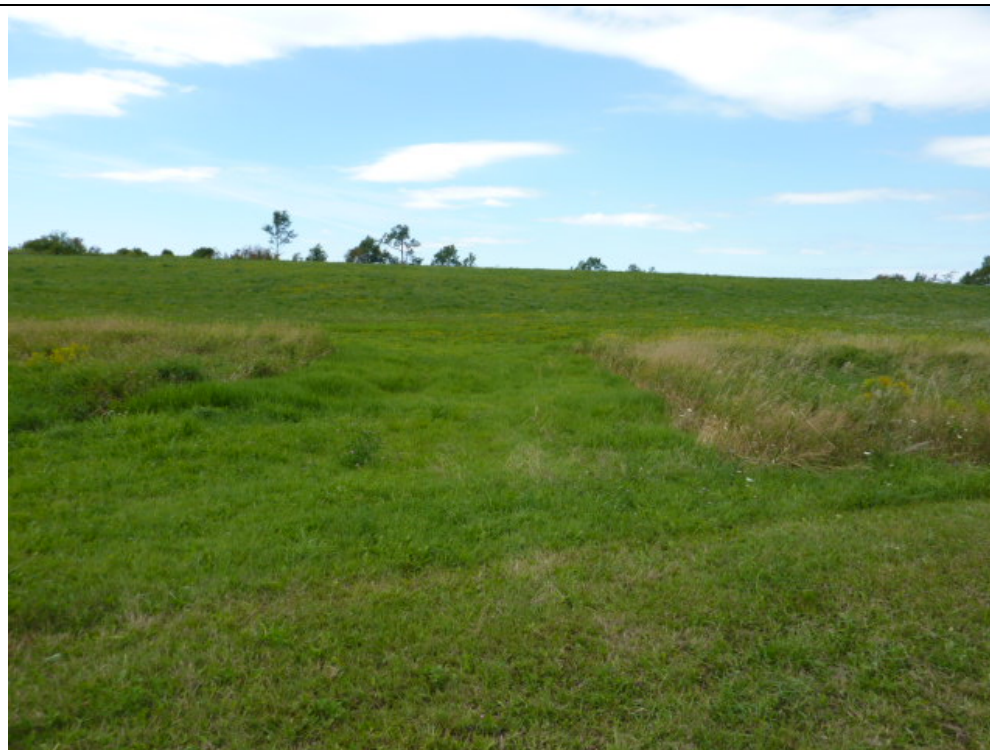
**Photo 9**

upstream (**Photo 9, Appendix D**). During field investigations in August 2011, this same crossing was observed to be dry and highly vegetated as shown in **Photo 10, Appendix D**. Ploughing activities along the edge of riparian habitat have created pooled water and overland drainage within depressed tire tracks throughout the project location setback (**Photo 11, Appendix D**).

Crossing along  
Stream 2  
during dry  
conditions.

Facing west.

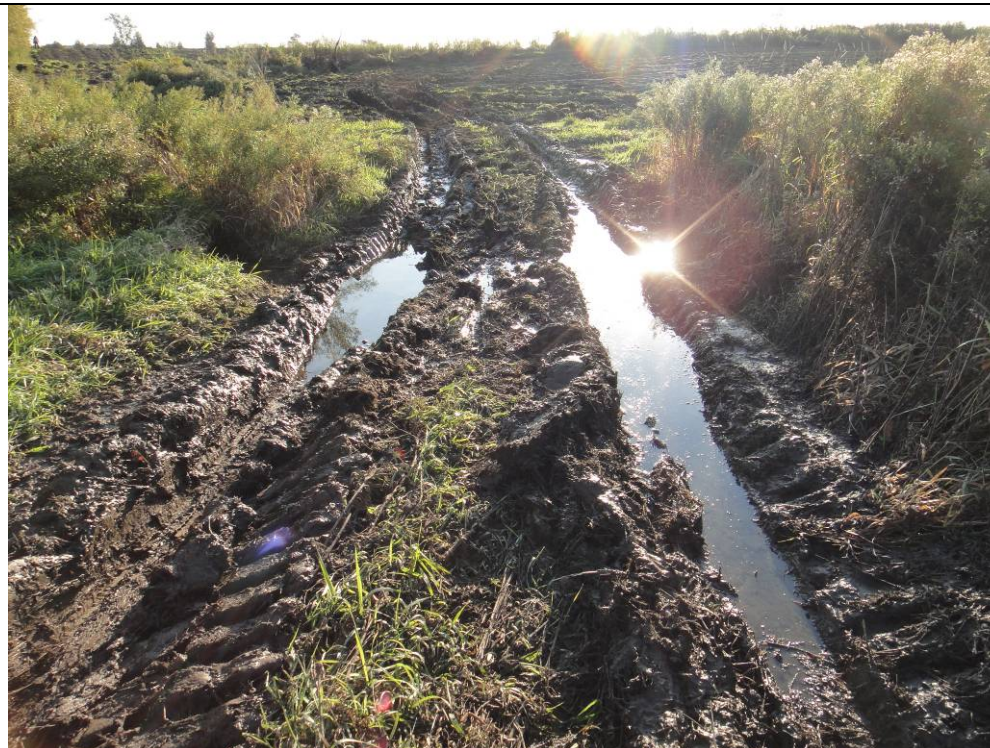
**Photo 10**

Standing  
water  
conveying low  
flow within  
depressed tire  
tracks along  
the northern  
extent of  
Stream 2  
within the  
land parcel.

Facing east.

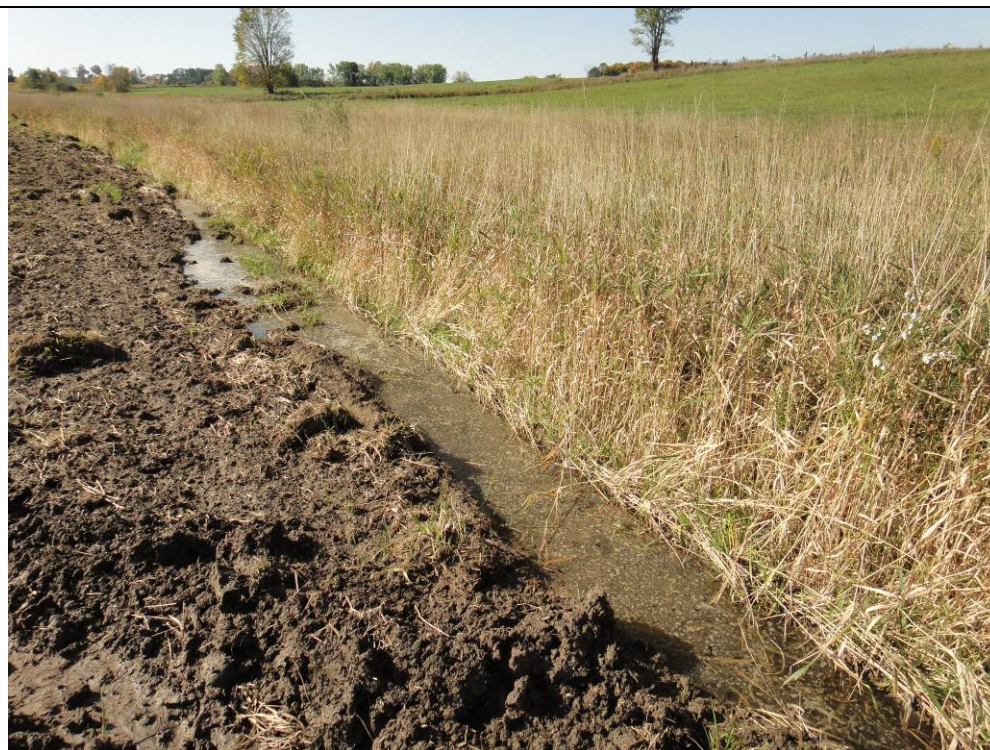
**Photo 11**

Annual row  
crops in the  
setback area.

A mixed  
swamp  
community  
located  
beyond the  
project  
location and  
setback are to  
the north.
